The influence of non-visible damage on the performance of aircrew helmets.

Charlotte B Meeks*, Sarah E Day** and Andrew D Foreman*

*Materials and Energy Centre, **Air Division, QinetiQ Ltd.

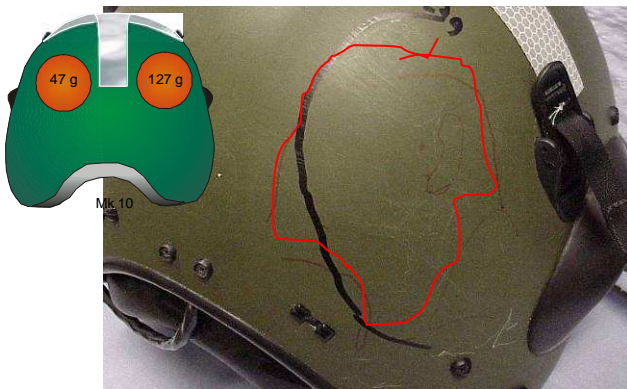
The helmets were investigated using the BondMaster and ANDSCAN methods. The study found that, due to the materials and methods used in the construction of the Mk 4 helmet, a high baseline attenuation was apparent during pre-impact NDE. As a result any minor damage following impact was indistinguishable. On the Mk 10 helmet the vibration and ultrasonic techniques were able to identify areas of damage. The extent of the damage region is identified in Figure 2.

Figure 2: Photograph showing damage area detected using ultrasonic and vibration NDE techniques.

It was observed that the areas around the attachments could not be investigated due to large attenuation changes. This is likely to be a significant problem for detecting damage in in-service helmets as previous investigations [4] have shown that many accident damaged helmets have damaged areas near to helmet attachments.

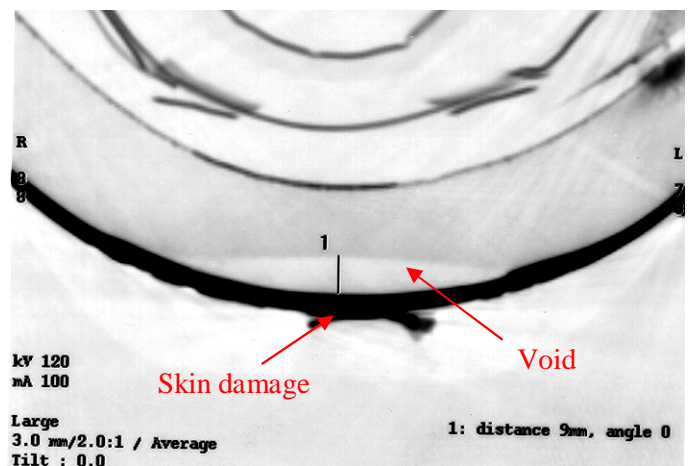
-scanning was a useful technique when looking for damage in the helmet skins and within the foam of the Mk4 helmets [4]. Mk4 helmets were characterised by the compressed polystyrene foam following impact; a phenomena termed 'residual set'. The shape of this region indicated both the impactor shape and applied force, see Figure 3. It was found to be more difficult to detect damage in the foam of the Mk10 helmets because there was minimal residual set in the polyurethane liners.

Figure 3: CT-tomogram showing damage in the polystyrene attenuating foam and skin of a Mk4 helmet.

Although the CT scanning technique was found to be successful in characterising significant foam damage (in the Mk4) it was not able to detect small skin/foam delaminations in either the Mk4 or Mk10 helmets. This was largely due to interference from metal attachments in the helmet.

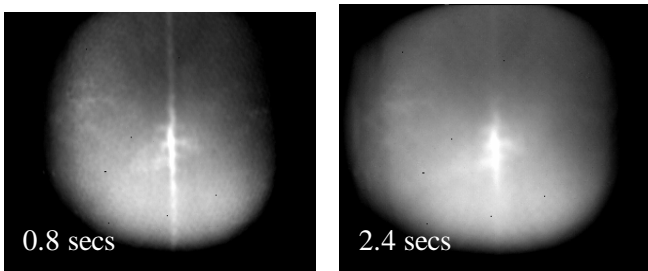
Thermography was found to be the simplest and quickest technique for examining any impact damage. The technique was able to determine various forms of damage, both within the paint layer and shell. Figure 5 shows the thermography images of the helmet after a duration of 0.8 seconds and 2.4 seconds. The time of the image is directly related to the position of the artefact through the thickness of the skin. The second image shows a larger damage area, corresponding to the fact that the damage within the skin is larger towards the back (inner) surface of the helmet shell; approximately twice the delamination area.

Figure 5: Thermography image of helmet after 0.8 secs and after 2.4 secs.

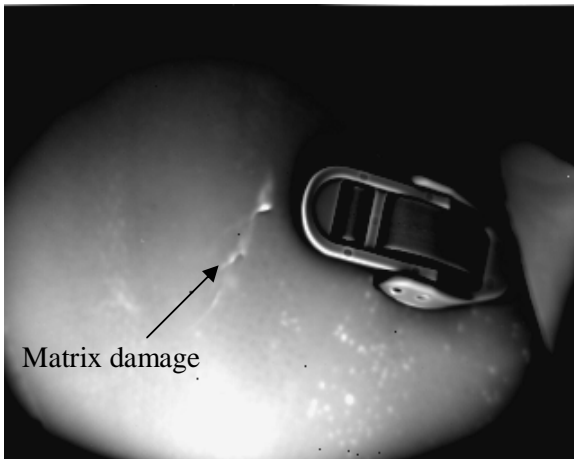
Unlike the previous NDE techniques investigated, thermography was not affected by the presence of the metallic attachments; therefore it was possible to investigate damage in all parts of the helmet (see Figure 6).

Figure 6: Thermography image showing skin damage on the side of a Mk10 helmet.

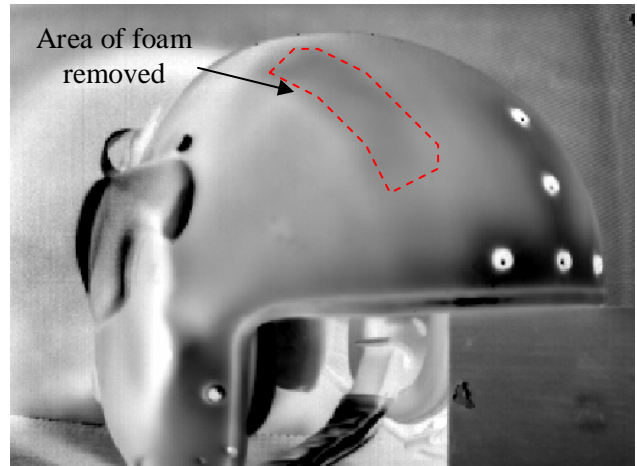
To investigate the ability of the technique to determine skin/foam debonding, a section of foam liner was removed from a Mk10 helmet. Figure 7 shows the thermography image recorded. Although it was possible to detect the missing region of foam liner, the images were not thought to be suitably reliable and hence it was concluded that the technique would not be able to determine foam liner debonding or crushing.

Figure 7: Thermography image showing variation in heat transfer at the skin/foam interface.

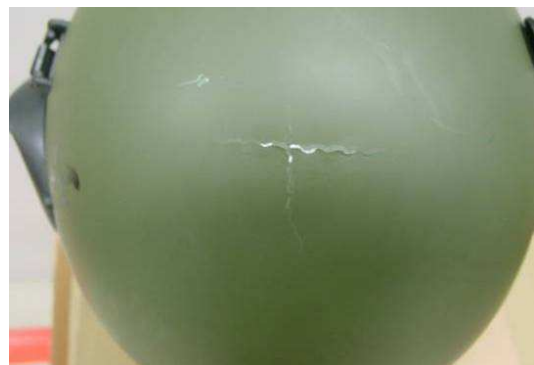
In general, it was noted that most low energy impacts onto the Mk10 helmet resulted in minor visible damage to the surface. Only impacts from less than 0.25m (approximately 50 G measured headform deceleration) resulted in an undamaged surface. The surface damage ranged from cracking in the paint layer to splitting of the shell. Figure 8 shows typical surface damage at 0.5 m impact.

Figure 8: Impact damage on the top of a Mk10 helmet after an impact from 0.5m.

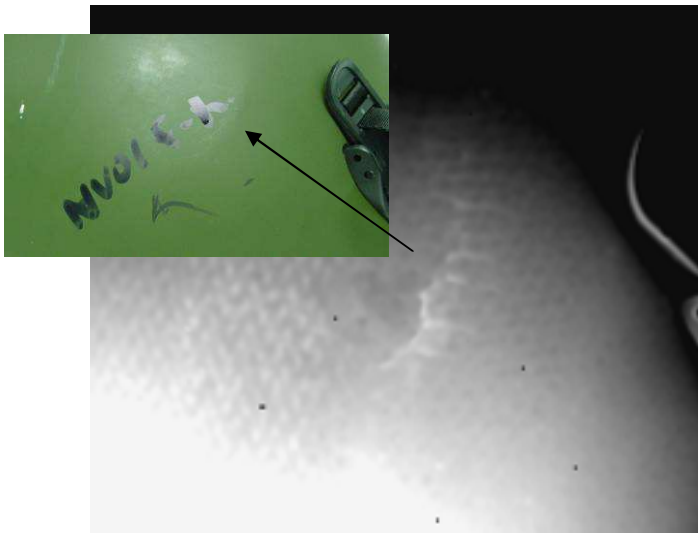
To determine if there was any non-visible damage within the helmets, each of them was inspected using thermography. This confirmed that there no internal damage could be found in the Mk4 unless accompanied by significant surface damage. For the Mk10s, internal matrix cracking was found in several of the helmets that appeared to show no visual damage (illustrated in Figure 9).

For both helmet types the visible damage area was usually smaller than the damage within the skin.

Figure 9: Thermography image showing damage in the shell.

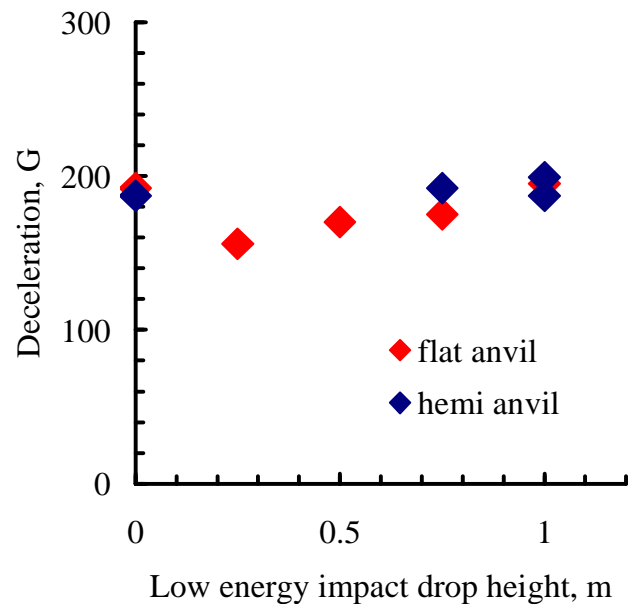
Figure 10 shows the peak deceleration results trace for a series of Mk10 helmets that had been subjected to a single impact from a height of up to 1m before residual testing. The data suggests that there was no detrimental affect from the previous low energy impacts.

Figure 10: Residual test results for Mk 10 helmet impacted on rear after low energy impacts on hemi and flat anvils.

Four helmets, three impacted onto a flat anvil from 0.75, 0.5 and 0.25 m, and an un-impacted baseline, are compared in more detail. The results suggested that the stiffness of the prior impacted helmets was reduced to increasing extents in comparison to the baseline helmet. This was not unexpected as each of the prior impacted helmets had some visible skin damage. The data also suggested that, for all of the pre-impacted helmets, a change in the properties of the foam had occurred compared to the baseline.

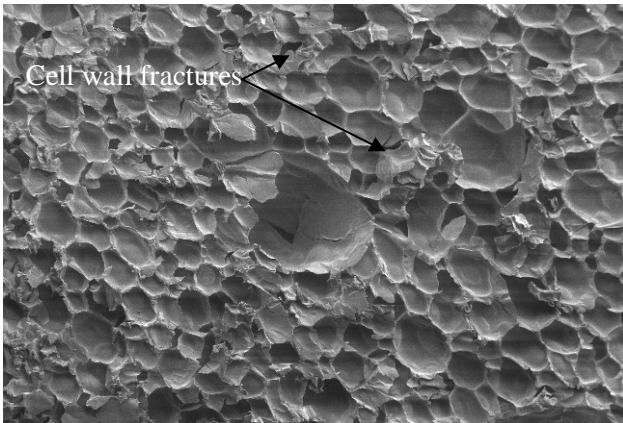
To identify the cause of the reduction in the foam properties an impacted area of foam was removed from a helmet which had been impacted from 1m. Figure 11 shows an electron microscopy image of the extracted foam. Small discrete fractures were noted throughout the foam which were the likely explanation for the reduced mechanical properties observed.

Figure 11: SEM image showing small fractures in the foam cell walls, x52.

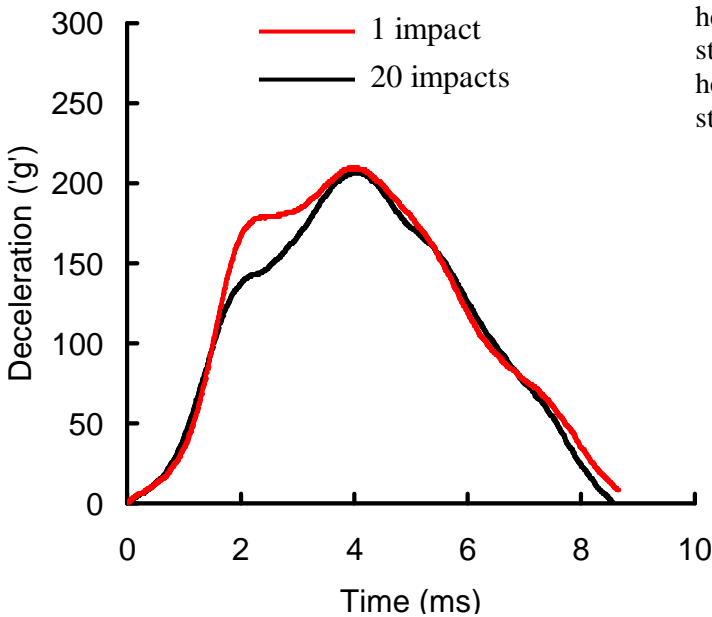
Figures 12 and 13 show the residual test results for Mk10 helmets impacted on the top once and 20 times. The results showed that at this location there was a negligible effect on the residual skin stiffness and foam response following repeated impacts.

Figure 12: Graph of residual test results following repeated low energy impacts.

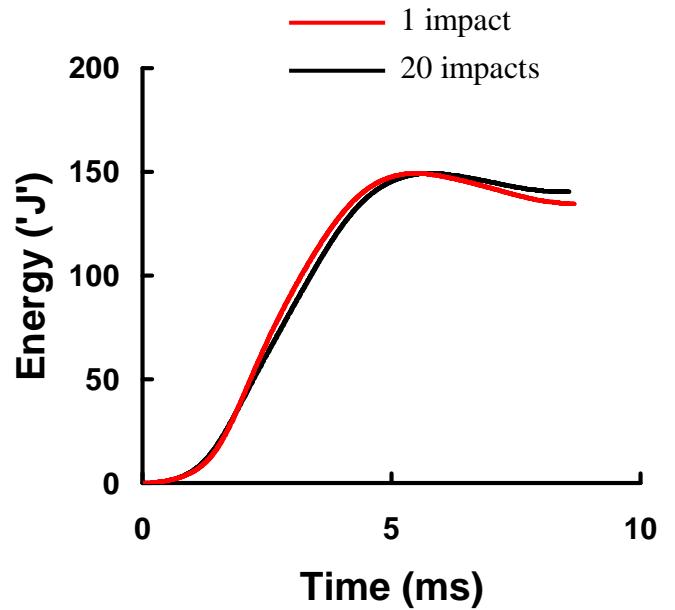
Figure 13: Graph of residual test results following repeated low energy impacts.

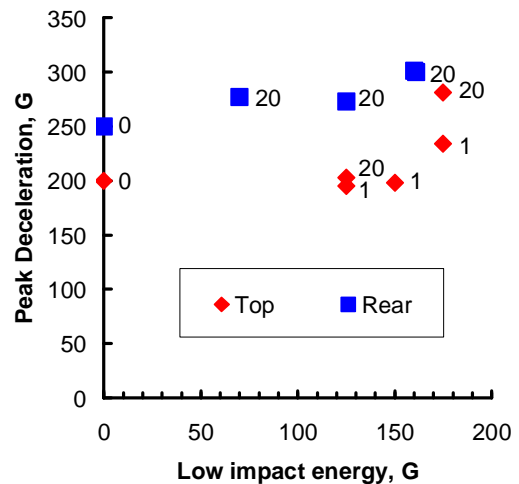
Figure 14 shows the peak deceleration results for a series of Mk4 helmets after residual testing. The helmets again had been subjected to impacts from a height of up to 2m before residual testing. As with the Mk10 helmets, there appears to have been no detrimental affect from the low energy impacts

Analysis of the residual data for the Mk4 helmets did not clearly show the same reduction in stiffness and foam properties as noted in the Mk10 helmets. This was most likely due to the heavier structure of these helmets.

Figure 14: Residual test results for Mk 4 helmet impacted on top and rear after either 1 or 20 (indicated by number next to point) low energy impacts on a flat anvil.
